# On the Seismic Response of the Building of the Faculty of Architecture and Engineering at Tohoku University

The building of the Faculty of Architecture and Engineering at Tohoku University survived two strong ground motions. Its survival is not surprising because the structure was stiff and strong. What is more surprising is the fact that the first ground motion did not cause severe structural damage while the second motion caused so much structural damage that the building had to be evacuated and demolished. The damage occurred despite two key facts: 1) the intensities of the mentioned ground motions are inferred to have been similar, and 2) the building was strengthened after the first motion (and before the second) following stringent standards.

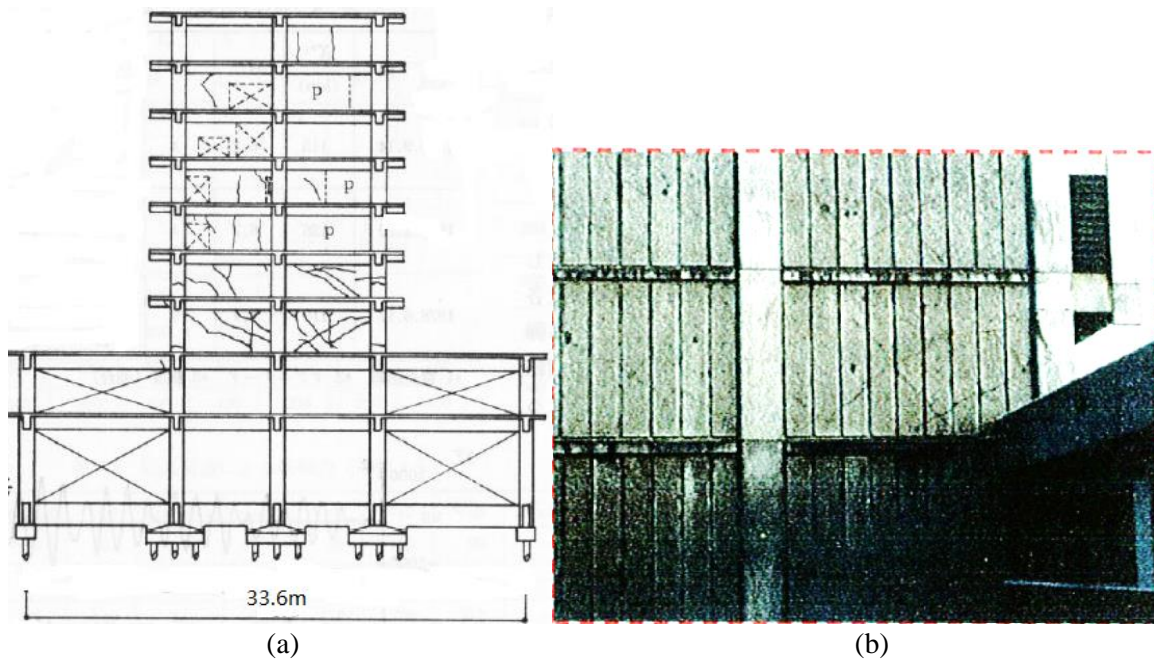
The earthquake caused shear and flexural cracks (with thicknesses not exceeding 1mm) in the exterior shear walls (Figure 4), short beams, and a few columns of the third and fourth stories (Shiga et al., 1981). Approximately 2.5% of the windows broke and furniture overturned.

**Figure 4:** Damaged observed in 1978: (a) crack map of the exterior wall along axis 2 (Shiga et al., 1981), (b) photo taken after the earthquake of 1978 showing cracks in second, third, and fourth stories.

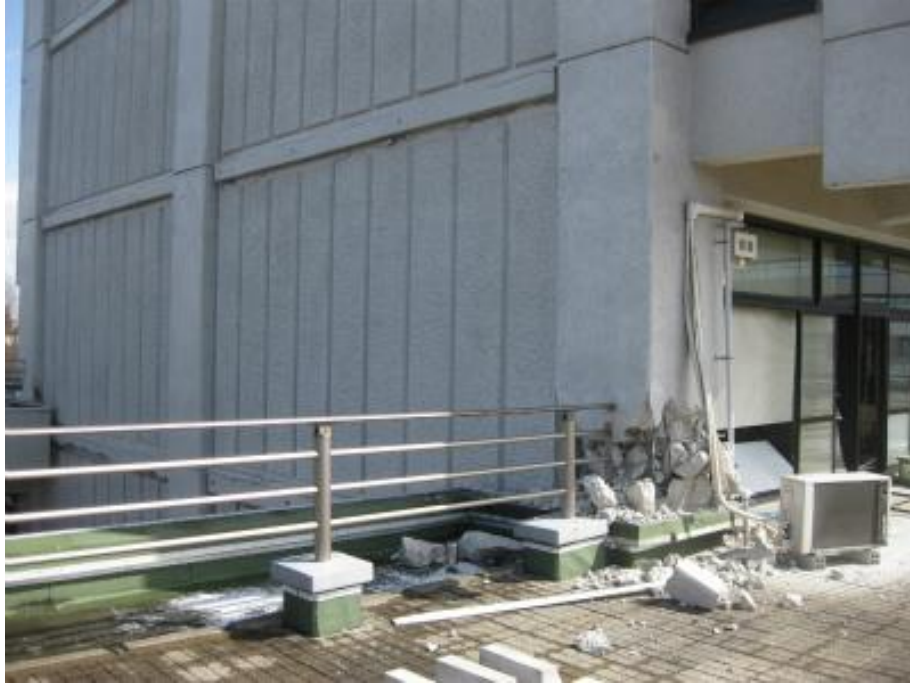
The damage concentrated at the base of the third floor in the exterior walls oriented in the N-S direction (Figure 7). The concrete in the boundary elements of these walls disintegrated along heights of up to 0.8 m. Longitudinal reinforcement buckled and/or fractured. The joint between the original beams and the web of the walls cast in the retrofit of 2001 was damaged: the concrete at the top of the beams spalled and top beam reinforcement was exposed. The interior C-shaped walls in the third floor had shear and flexural cracks, and spalling at the level of the 4th floor.

**Figure 7:** Damage to exterior walls after the earthquake of 2011: (a) disintegrated boundary element, (b) damage to beam-web joint and intermediate column

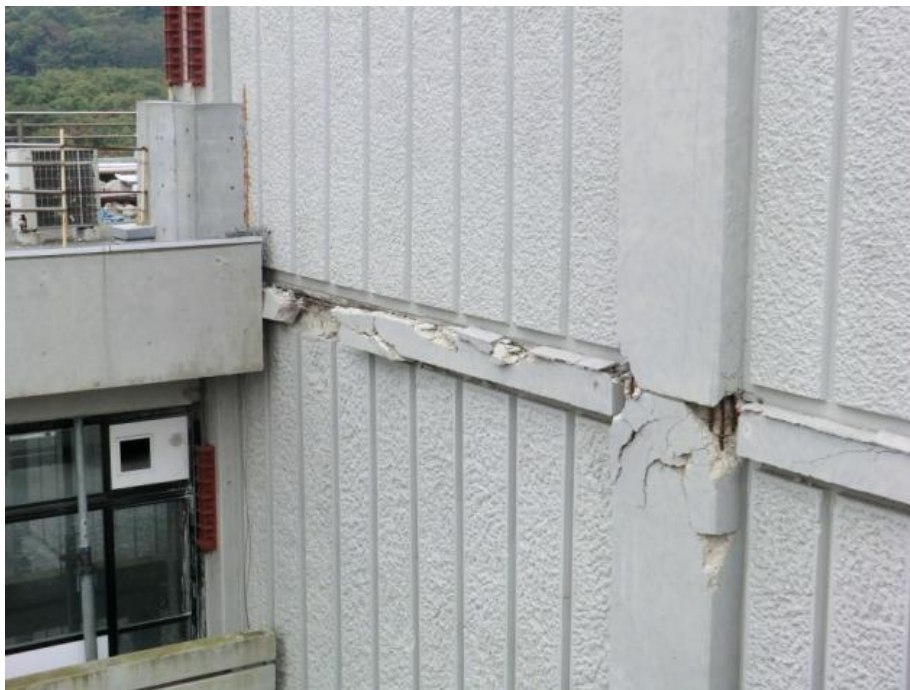
(b)

b) Figure 7b shows the damage caused by the 2011 earthquake to the intermediate column (at intersection 2C) in the exterior structural wall on the east elevation of the building. The deformed reinforcing bars buckled despite the fact this column was unlikely to experience large compression forces during ground motion. Vertical splitting cracks in the column may have been the result of

reinforcement buckling. Such cracks were not visible in the web, where damage tended to concentrate around the bottom ends of the anchor bolts installed in 2001.

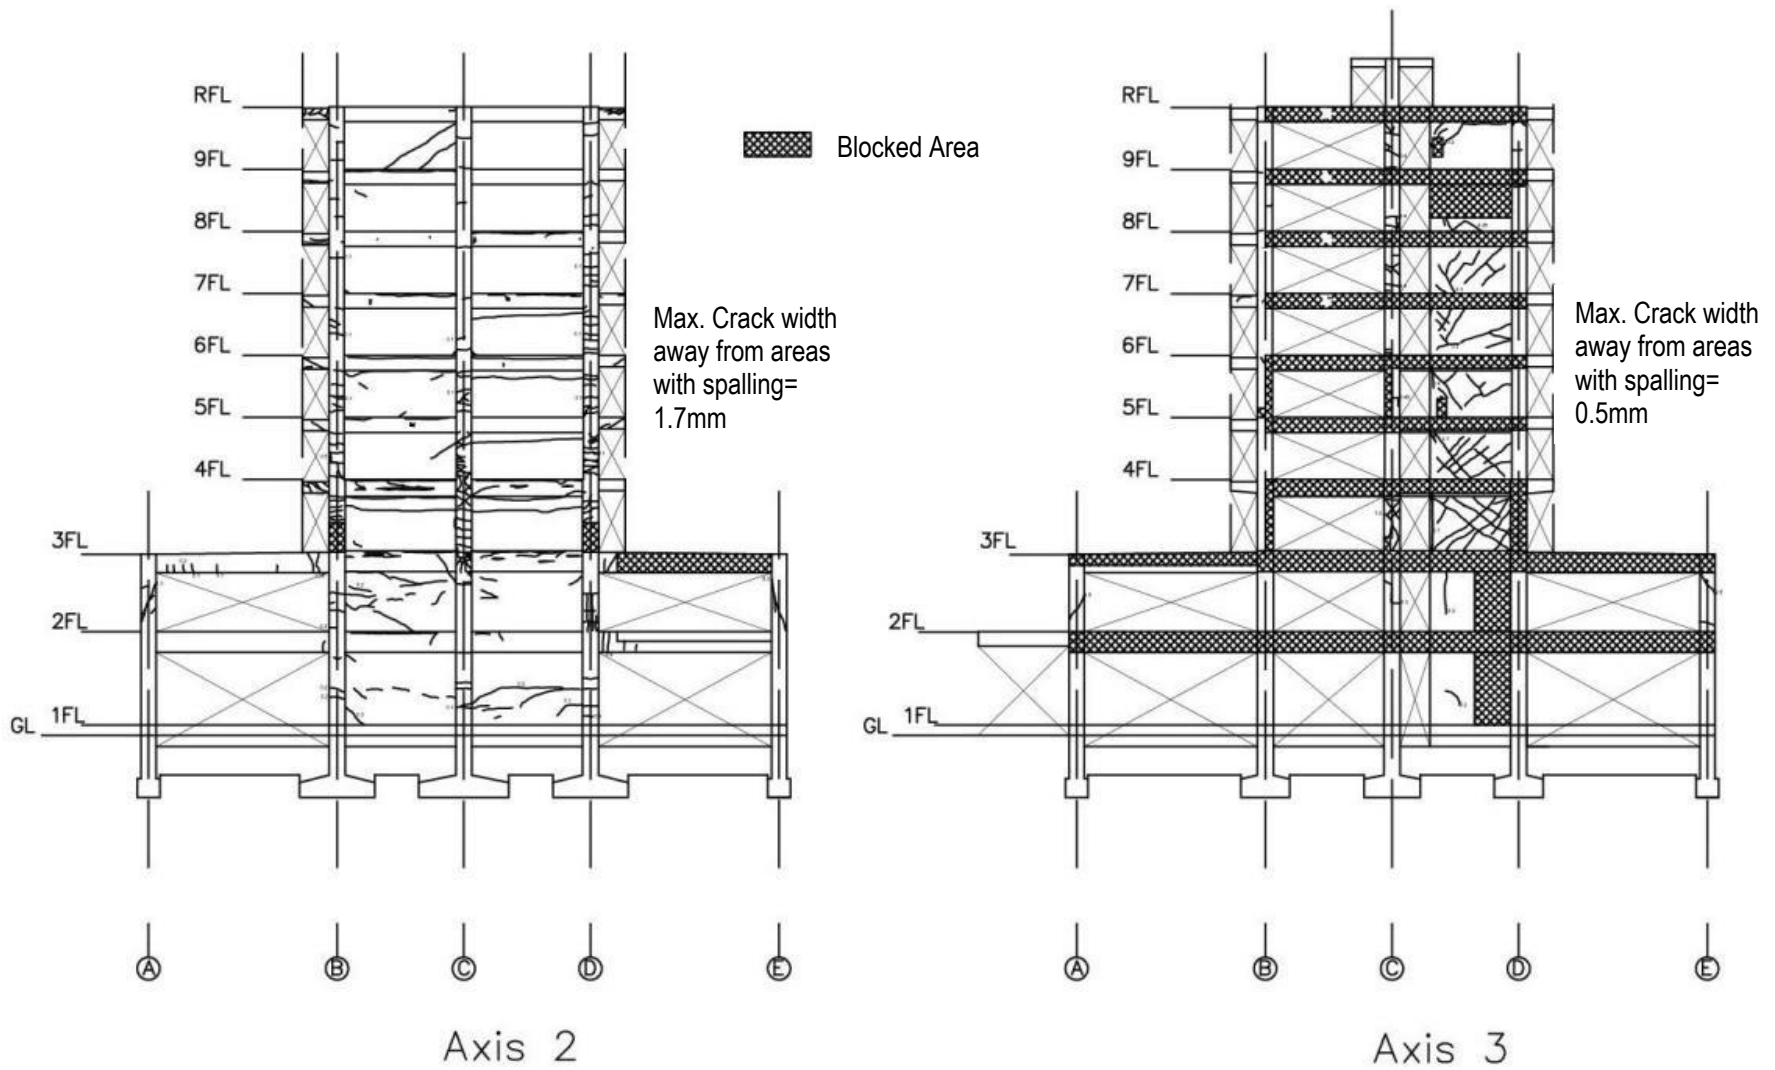
Surveys of the building were done in October 2011, March 2012, and June 2012. Figure 8 shows crack maps obtained in those surveys for Axes 2 and 3.

The cracking away from the 3<sup>rd</sup> floor beams is also revealing and shows that shear deformations (and cracks) were larger in 1978 than in 2011, when the deformations seem to have concentrated at horizontal wall-beam joints.

**Figure 8:** Crack maps obtained after the earthquake of 2011

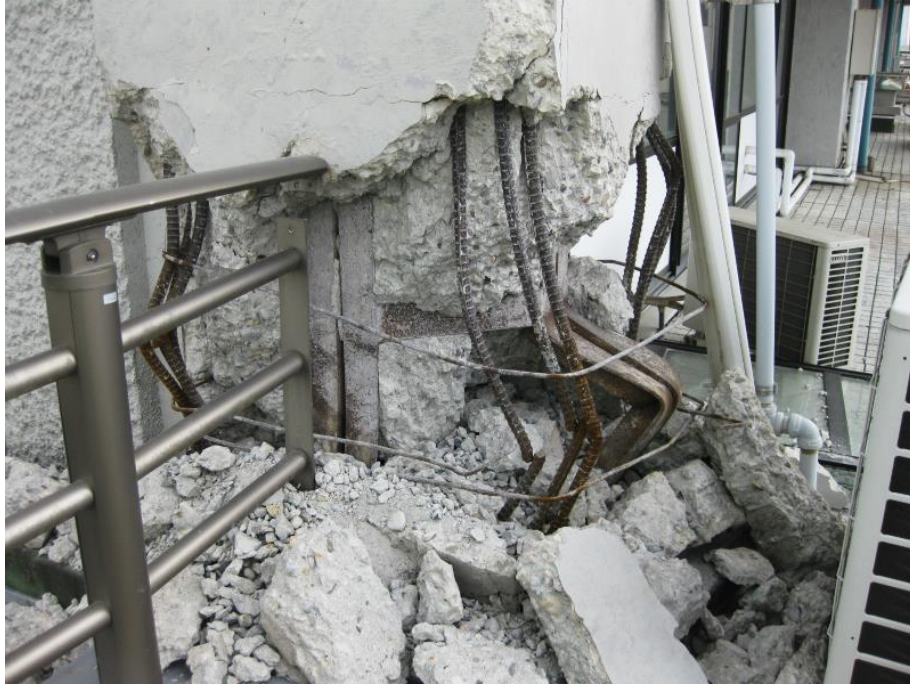
Figure 9 shows one of the columns that disintegrated during the 2011 earthquake. All deformed bars buckled. Some steel angles also buckled and remained buckled but, interestingly, other angles did not, and instead they remained straight and had fractures. The angles that were not buckled during the earthquake are likely to have fractured at welds or rivet holes. The angles that remained buckled must have either 1) fractured at rivet holes in the beam-column joint or 2) accumulated large plastic tensile deformations followed by compression. Studies of the steel samples extracted by Takenaka Corporation indicate that, away from rivet holes and welds, at least some of the reinforcing angles in the damaged columns did not reach large plastic deformations. The observed buckling may have resulted from a sequence of events starting with fracture in the beam-column joint followed by pullout and ending with buckling (Figure 11). The buckling of vertical reinforcing angles may have triggered the observed spalling of the column concrete shell. Wall sliding is unlikely to help explain the combination of buckling and fractures observed. The following observations provide more insight:

**Figure 9:** Base of boundary element at third floor

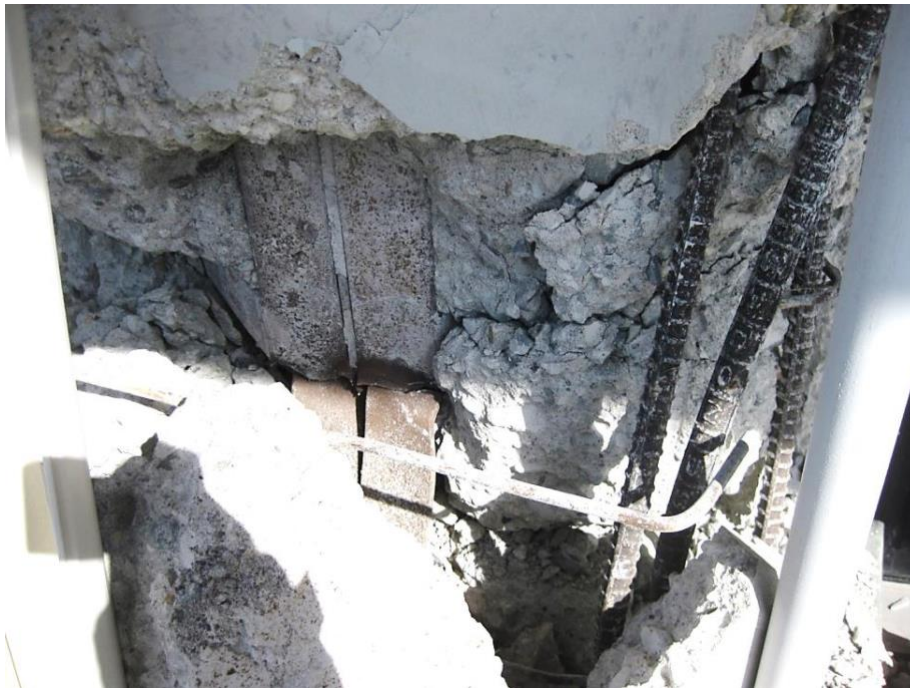
Observations a and b above support the idea that spalling was caused by the following process: 1) the angles fractured in tension either in the beam-column joints or in the bottom region of the columns, 2) the deformed bars had enormous tensile strain near the fractured angles, 3) the deformed bars buckled when the tensile strain decreased, and 4) the angles fractured in the beam-column joints buckled as shown in Fig. 11 while those fractured in the columns did not.

**Figure 10:** Fracture at weld

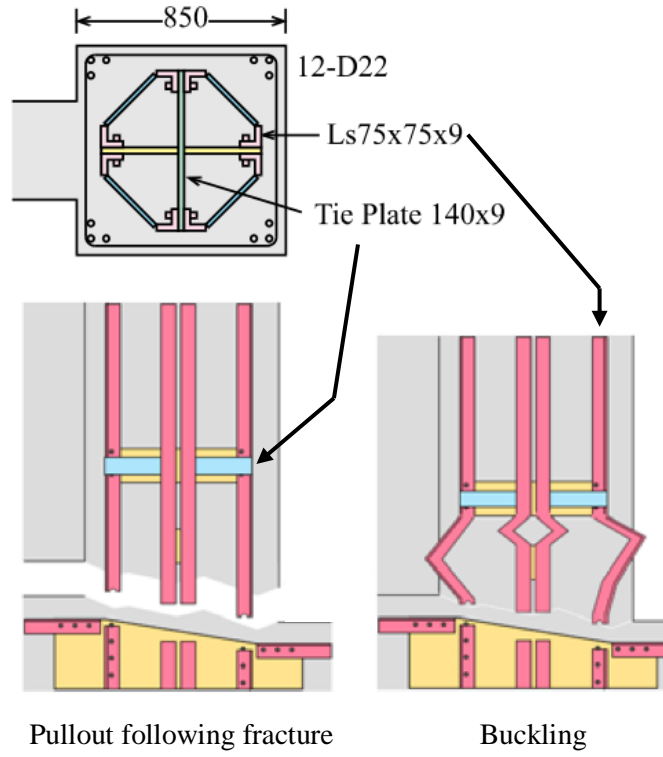
**Figure 11:** Plausible failure sequence (dimensions in mm)

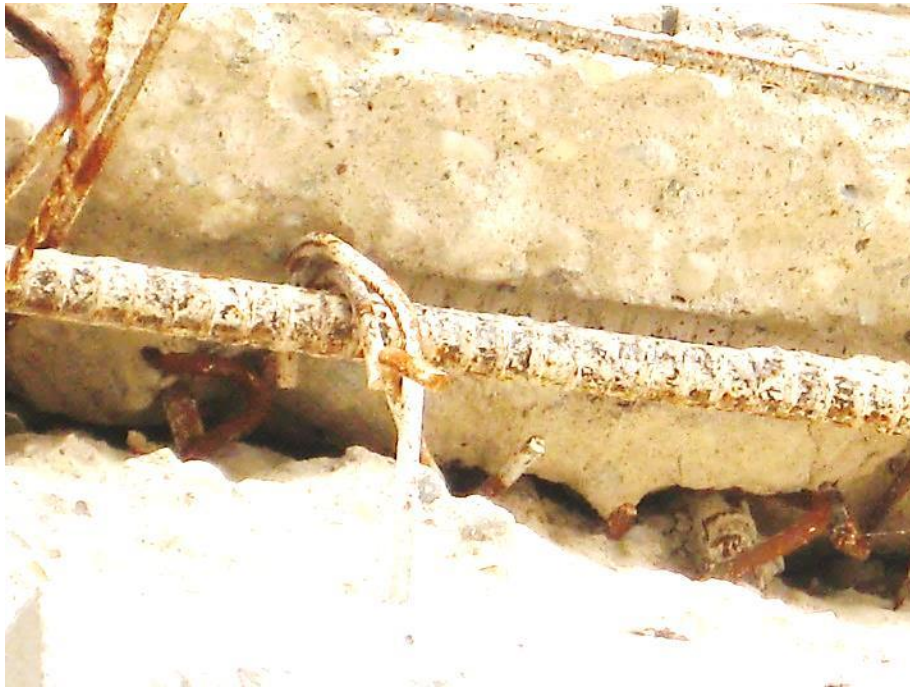
Figure 12 shows the top of a 3<sup>rd</sup>-floor beam after the 2011 earthquake. The figure shows:

- 1) Anchor bolts that pulled out of the beam forming “conical” failure surfaces in the concrete
- 2) Buckled plain vertical bars which were part of the original web reinforcement
- 3) Beam stirrups
- 4) Beam top longitudinal reinforcement

The buckled plain bars were embedded in the webs cast in 2001 approximately 20 bar diameters. They are unlikely to have developed their strength in such a short length. Again, the observed buckling may be the result of pullout failures followed by compression. Figure 13 shows a cross section of the web-beam joint as modified in the retrofit. Observe that the dotted line does not cross any reinforcement anchored effectively to resist large tensile forces. At this location, the exterior walls were essentially unreinforced. A tensile failure at this location is likely to have occurred at a small wall drift and may have altered drastically the response of the wall as discussed later. Pullout of the anchor bolts explains the concentration of damage seen in the web. This type of failure could have been avoided had the concept of “capacity design” been followed closely (Sullivan, 2010). The anchorage of reinforcement needs to be stronger than the reinforcement itself.

**Figure 12:** Close up of web-beam joint
