# On the Seismic Response of the Building of the Faculty of Architecture and Engineering at Tohoku University

The building of the Faculty of Architecture and Engineering at Tohoku University survived two strong ground motions. Its survival is not surprising because the structure was stiff and strong. What is more surprising is the fact that the first ground motion did not cause severe structural damage while the second motion caused so much structural damage that the building had to be evacuated and demolished. The damage occurred despite two key facts: 1) the intensities of the mentioned ground motions are inferred to have been similar, and 2) the building was strengthened after the first motion (and before the second) following stringent standards.

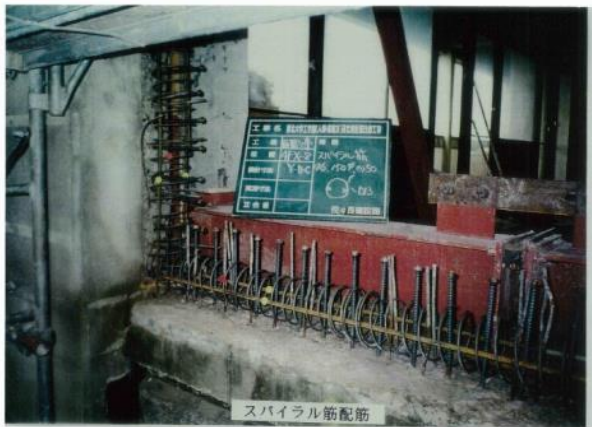
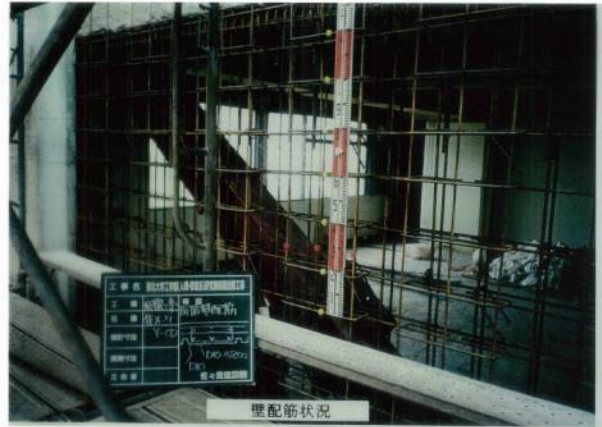
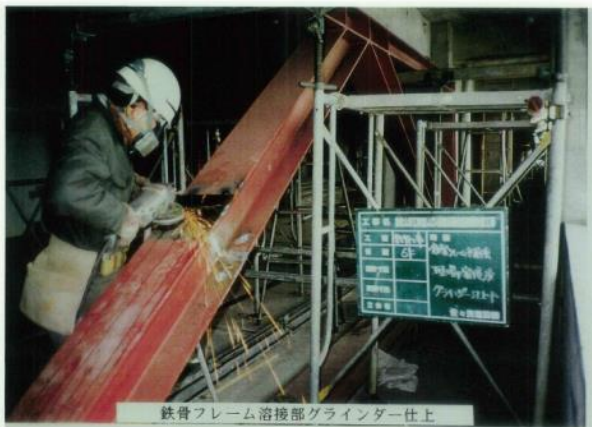
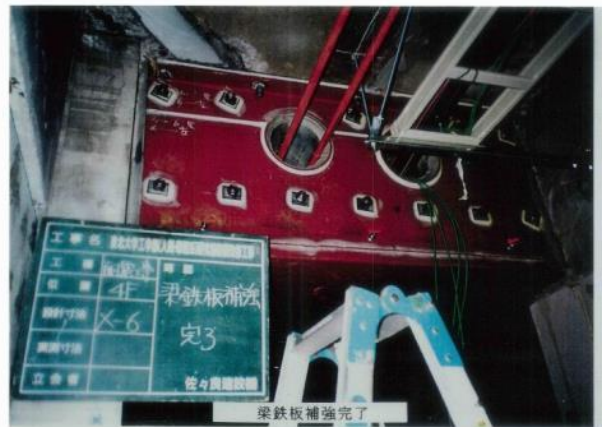
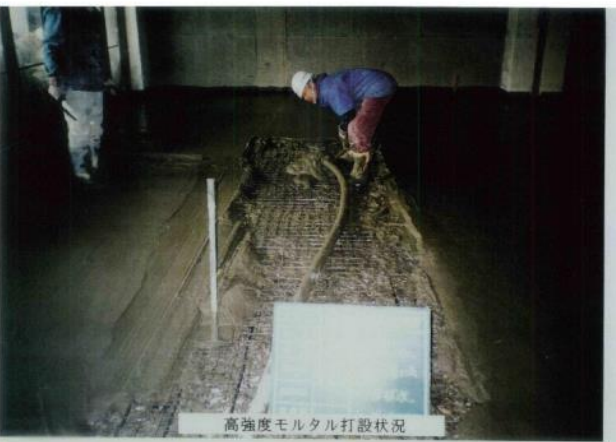
In 2001 the building was retrofitted to reduce torsion and increase the shear strength of the exterior walls in the N-S direction. The retrofit was limited to the upper seven stories. The concrete of the webs of the exterior walls in the N-S direction (Axes 2 and 7) was replaced with thicker cast-in-place webs made with concrete with a cylinder compressive strength of 300 kgf/cm<sup>2</sup> (29 MPa, 4.3 ksi). Steel jackets were mounted on short beams in the interior frames (Axes 3 to 6 between Axes C and D) in the N-S direction. These beams were expected to be vulnerable to shear. Steel braces were fitted into two bays of the southernmost frame (Axis B between Axes 3 and 4 and Axes 5 and 6) in the E-W direction to reduce torsion, and portions of the floor slabs (between Axes 2 and 3 and Axes 6 and 7) were thickened and reinforced with additional steel welded wire. Figure 5 shows photographs taken during the retrofit.

**Figure 5:** Retrofit of 2011: (a) reinforcement at wall web-beam connection, (b) replaced wall web reinforcement, (c) exterior steel braces in South facade, (d) steel jacket on short beams, and (e) slab thickening (Courtesy of Tohoku University)

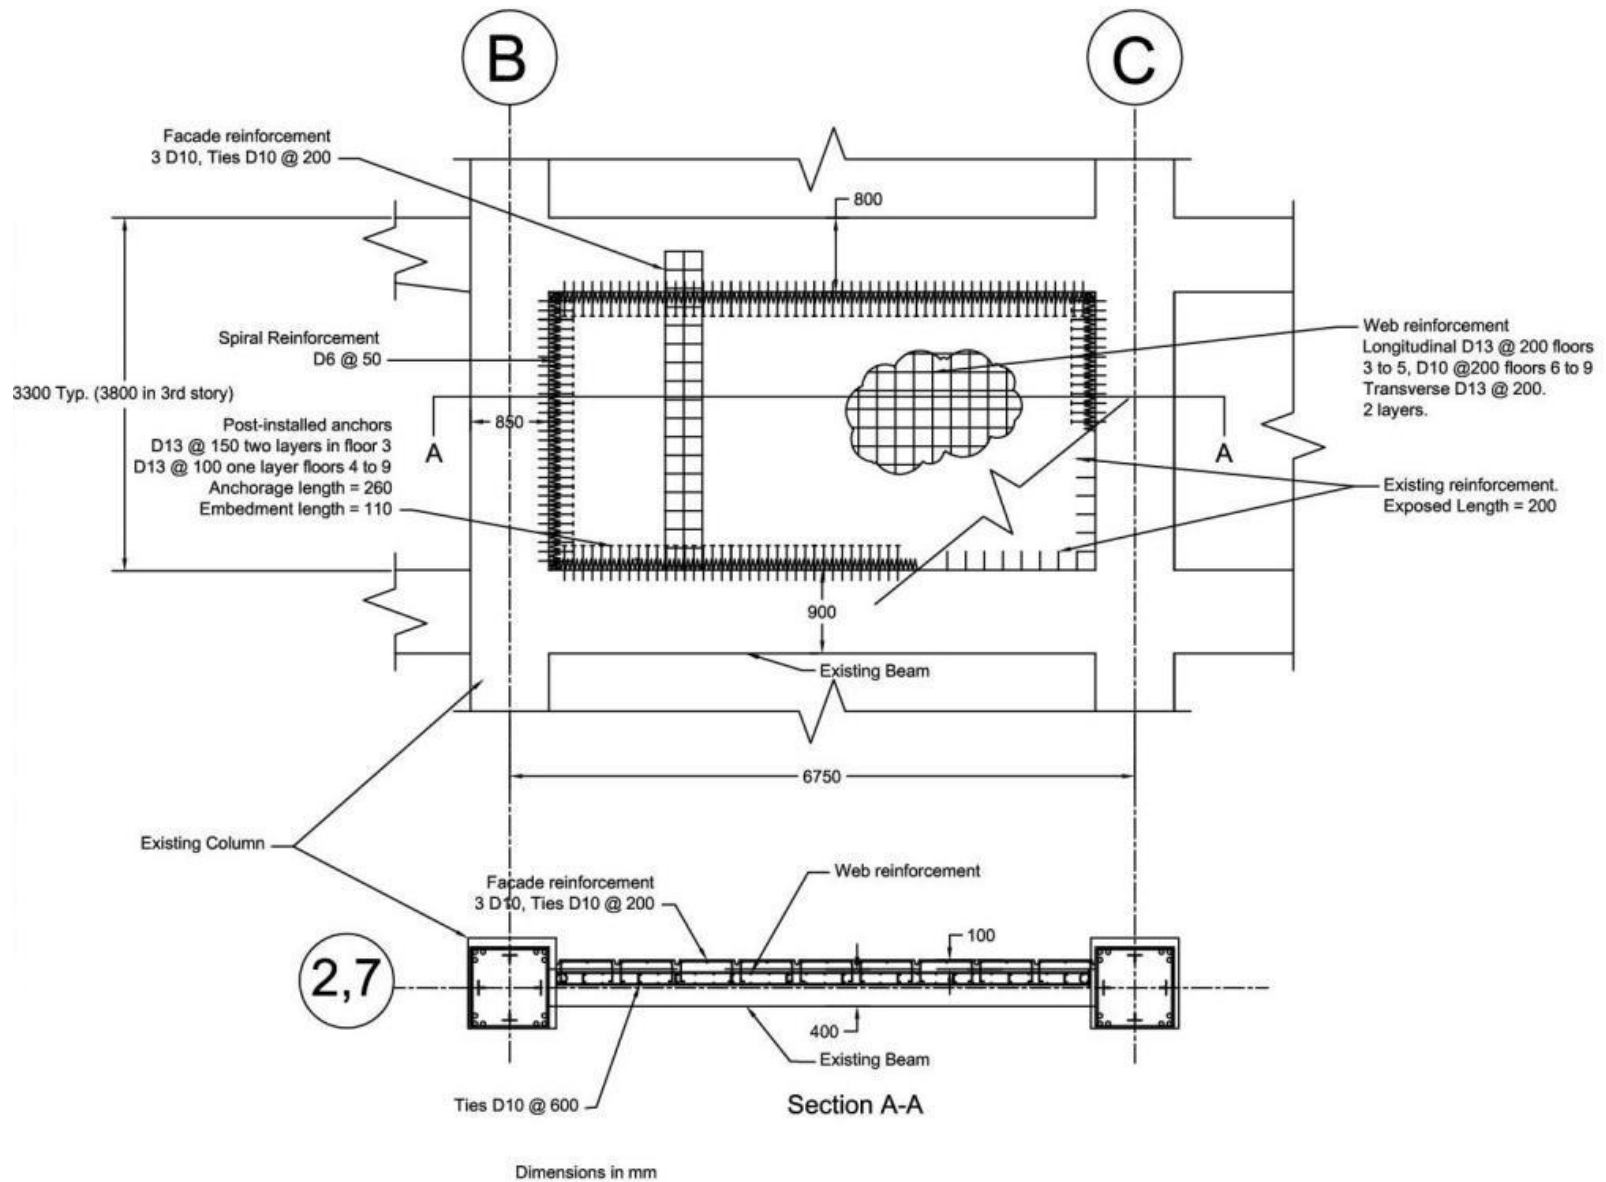
**Figure 6:** Details of the wall web reinforcement installed in 2001 (Appendix A)

Figure 6 shows details of the reinforcement used in the replaced wall panels. As the existing concrete of the webs of exterior walls (oriented in the N-S direction) was removed, the existing reinforcement was cut 0.20 m away from beams and columns. Post-installed anchors (deformed headed studs with 13-mm shafts and spaced at 0.10 m) were glued 110 mm into beams and columns, and were embedded 260 mm in the new webs. New web longitudinal and transverse reinforcement was provided in two layers (see Table 1 for details). Spiral reinforcement, with a bar diameter of 6 mm, a pitch of 50 mm, and an outer diameter of 120 mm, was provided around the perimeter of the new webs.

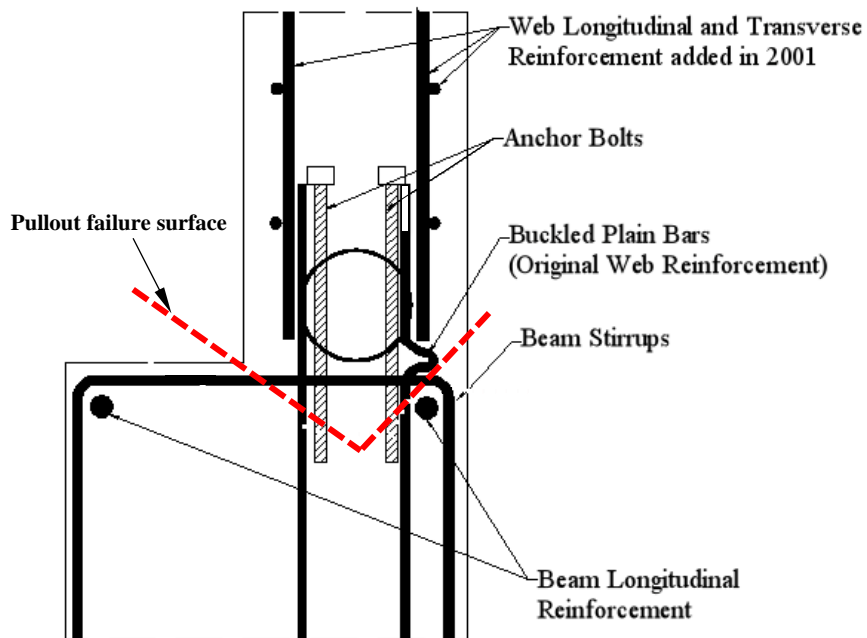
**Figure 13:** Cross section of web-beam joint

The buckled plain bars were embedded in the webs cast in 2001 approximately 20 bar diameters. They are unlikely to have developed their strength in such a short length. Again, the observed buckling may be the result of pullout failures followed by compression. Figure 13 shows a cross section of the web-beam joint as modified in the retrofit. Observe that the dotted line does not cross any reinforcement anchored effectively to resist large tensile forces. At this location, the exterior walls were essentially unreinforced. A tensile failure at this location is likely to have occurred at a small wall drift and may have altered drastically the response of the wall as discussed later. Pullout of the anchor bolts explains the concentration of damage seen in the web. This type of failure could have been avoided had the concept of “capacity design” been followed closely (Sullivan, 2010). The anchorage of reinforcement needs to be stronger than the reinforcement itself.

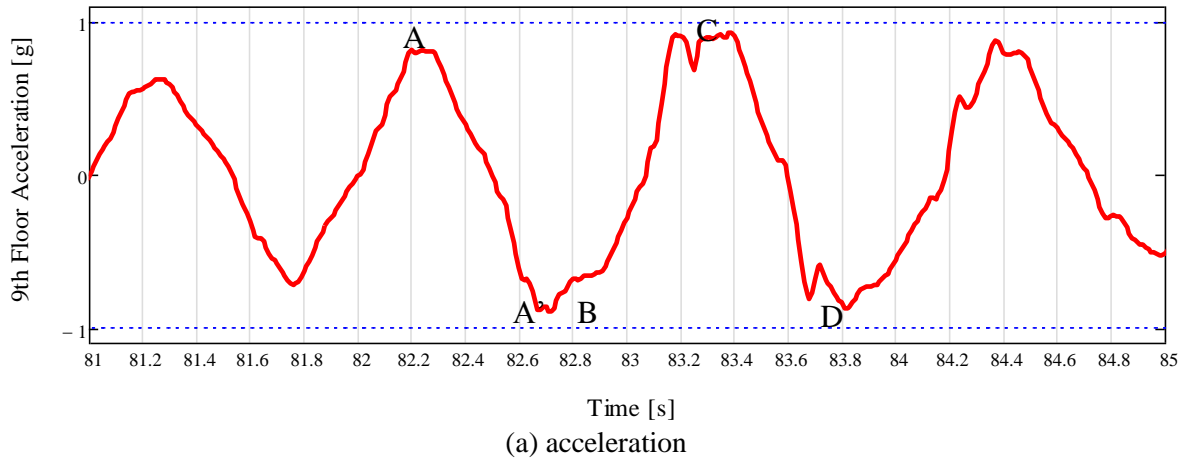
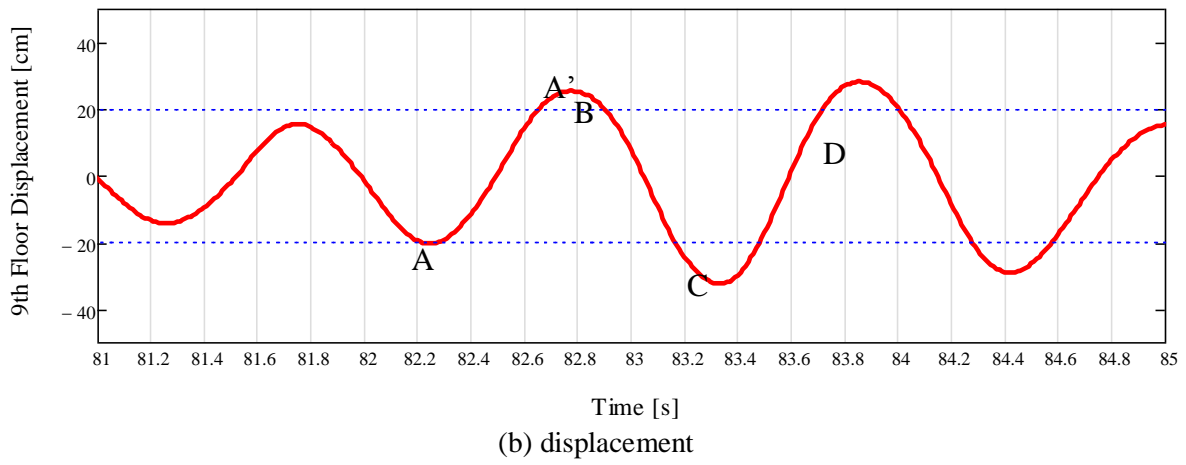
**Figure 20:** Close-up views of ninth-floor acceleration and relative-displacement histories (2011)

show that the effective period of the building was approximately 1 sec. in the same ground motion. The same is true for the initial part of the 2011 record<sup>a</sup>. Nevertheless, 82.2 sec. into the 2011 motion something occurred to the structure. The 2011 acceleration record reached a plateau (Figure 20) indicating that yielding may have occurred<sup>b</sup> as the displacement reached the maximum displacement reached in 1978 (21cm). As the building swayed in the other direction a radical event took place. The acceleration reached another plateau at approximately 82.7 sec. and soon after it decreased abruptly. The acceleration plateau was reached at an estimated displacement of approximately 21 cm. The abrupt acceleration drop occurred at an estimated displacement of nearly 23 cm. We do not claim to have the accuracy to estimate these displacements within 1 cm. We display the unwarranted number of significant figures simply to stress that the observed drop in acceleration occurred at a displacement comparable to the maximum displacement reached in 1978 confirming what the linear displacement spectra suggested (i.e. that the displacement demands were similar in 1978 and 2011). Additional abrupt drops in acceleration took place at 83.2 sec. and 83.7 sec. From that instant on, the structure had an increased effective period of approximately 1.2 sec.

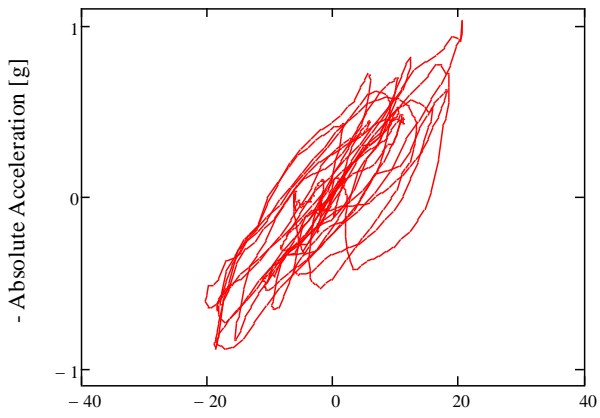
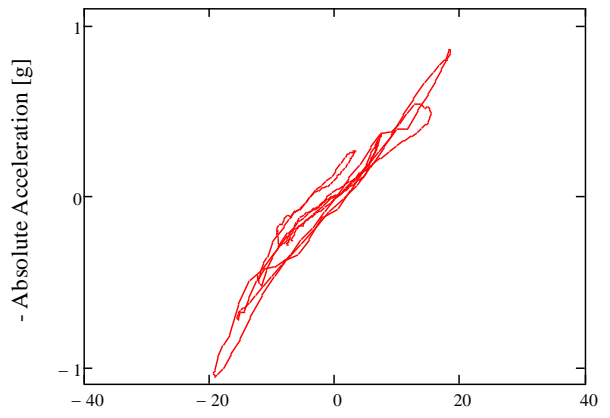
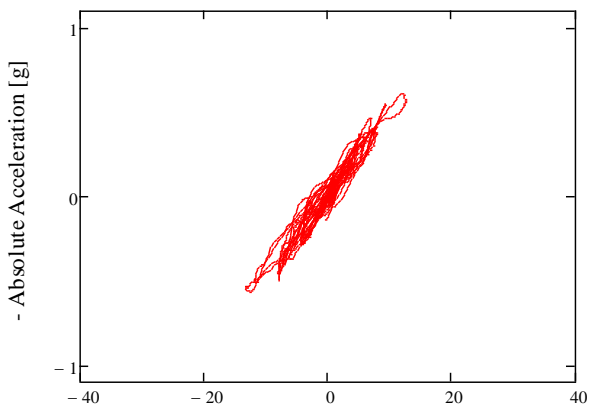
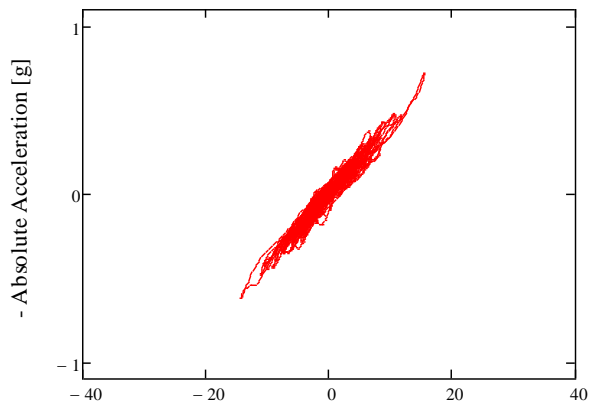
**Figure 21:** Initial 9<sup>th</sup>-floor acceleration-displacement response

Figures 21 and 22 show absolute acceleration – relative displacement curves estimated based on the records obtained on the 9th and 1st floors in the NS (transverse) direction. Interpreting these plots is not simple because they are sensitive to 1) the effects of higher modes and 2) the modifications made to the records to obtain sensible displacement estimates. With these limitations in mind we do notice in them the following consistent trends:

- 1) Wide hysteretic loops were observed only in the first 15 sec. of the 1978 motion (Fig. 21a)
- 2) After that instant, the structure responded nearly as an SDOF showing no clear evidence of stiffness decay or yielding until 82.2 sec. into the 2011 motion (Figs. 21b-d)
- 3) Yielding was first reached at a displacement of 20 to 21 cm (points A, A', Figs. 20, 22a)
- 4) At 23 cm the first large drop in acceleration (or strength) took place (point B, Figs. 20, 22a)
- 5) Two consecutive acceleration drops took place between 83 and 84 sec. (points C, D, Figs. 20, 22b)
- 6) After these drops, the structure was softer and retained the resulting stiffness for the rest of the motion
- 7) The peak acceleration in 1978 was higher than the peak acceleration in 2011 indicating that the strength of the structure may have decreased because the failure of anchor bolts occurred.
