Evolution of spall-damage in iron caused by repeated plate impacts: Ultrasonic evaluation

著者 (英)	N. Nishimura, K. Fujimoto, Y. Ogi, Toshihiro Ito
journal or publication title	Ultrasonics
volume	83
page range	88-93
year	2018-02
URL	http://id.nii.ac.jp/1476/00006412/

Abstract

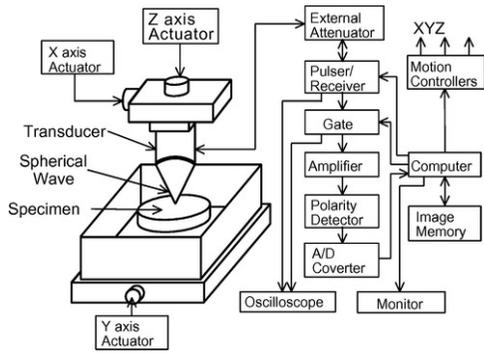
Fig. 2 The clarification of our acoustic microscopy provided in a graphical form. To suppress the ringing of the reflected wave, an external attenuator was added to the measuring circuit, while the additional oscilloscope was used to detect the acoustic wave reflected from the damaged zone.

In order to characterize the spall-damage generation and distribution induced in the target plate, we used the scanning low frequency acoustic microscopy (SLFAM, Olympus UH Pulse-100) the schematic given in Fig. 2, see also Refs. [4,6,13]). UH microscope employed the frequency range, gate width and memory size of 5-200 MHz, 20 ns-1 μ s and 640 \times 512 (8bit), respectively. The spall damage was examined by ultrasonic C- or B-scan images to visualize void/crack distributions, *i.e.*, C-scan in a plane parallel to impact plane at arbitrary depth, B-scan in a plane perpendicular to impact plane. The scanning acoustic images were obtained by detection of the amplitude of the longitudinal wave reflected from the elemental area of the specific defects such as inclusions, voids or cracks. The signal intensity recorded at each point was mapped as a set of spots of variable brightness (*e.g.*, Fig. 4 in the Results chapter). The following parameters were used in the experiments: the central frequency of 30 MHz, beam diameter at focus equal 0.28 mm and focal length (in water) of 25.4 mm [14] were achieved with the PolyVinylidene DiFluoride (PVDF) point-focus transducer, similarly as in previous work [8]. A PVDF transducer is free from the noise owing to the reverberation at the lens surface in the conventional transducer, therefore voids or cracks in arbitrary depth are properly revealed (see Ref. [8]).

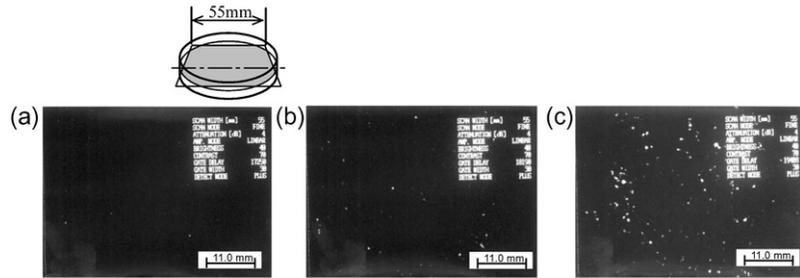
Fig. 4 The variation of spall-damage in commercially pure iron (sample No. N4) induced by consecutive impacts during repeated testing with the second impact stress (3.8 GPa) higher than the first one (2.8 GPa). The C-scan images taken at the depth of 3.5 mm below the impact surface illustrate the scenario after the first (a), second (b) and third (c) impact, for which the applied impact stress equaled 2.8, 3.8 and 4.9 GPa, respectively.

The C-scan images (Figs. 4-6) reveal spall damage created in the commercially pure iron after the first (a), second (b) and third (c) impact. These images were taken in the determined region of the target plate with the same imaging conditions. The white spots caused by reflected signal indicate the defects. In the repeated plate impact tests, we applied different sequences of impact stresses to selected specimens (see the details in Table 2) in order to establish relationship between the stress level sequence of impacts and the resulting damage. Our experimental results are completed by optical microscopy observation of the spall damage (the example given in Fig. 7). Thus the change in these images shows the damage evolution.

Indeed, when the stress of second and third impact is higher than the previous one (Fig. 4) the damage after the each impact increases. Interestingly, the development of the spall-damage was observed for all the evaluated depths (Figs. 5 and 6). This occurs systematically when the second impact stress is lower than the first one. Our conclusion applies to generated cracks, *i.e.*, the crack generated by the first impact (refer to Fig. 7) develops during the second one, despite its impact stress is lower, similarly to the test result for carbon steel [8]. Moreover, in a case when the third impact stress is slightly lower than the threshold spall stress, there is no difference in spall damage observed after the second and third impacts (Fig. 6). In order to detect the cracks growth, we applied the quantitative ultrasonic evaluation to these particular specimens.

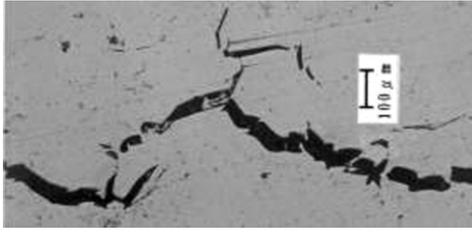
Fig. 7 The optical micrograph of the vertical cross-section of commercially pure iron specimen (sample No. N7) that indicates spall-damage to consists mainly of cracks. The image was taken after the first impact stress of 3.2 GPa.

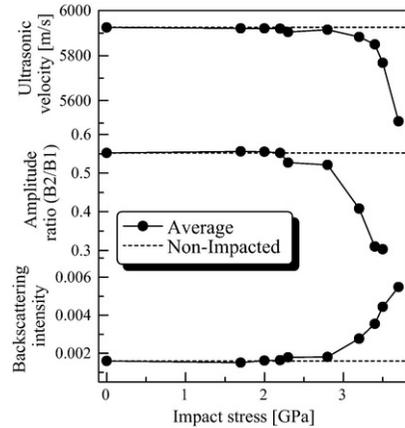
Fig. 8 Dependence of longitudinal wave (ultrasonic) velocity, amplitude ratio (equal B2/B1) and backscattering intensity on impact stress. The indicated ultrasonic variables were measured for the commercially pure iron after the first impact.

When the impact stress is lower than the threshold spall stress (approximately 2.3 GPa), the wave velocity, amplitude ratio, backscattering intensity and the amplitude spectrum are the same as for the non-impacted plates, as evident in Figs. 8 and 9. Indeed, even in the case of non-impacted plates, the amplitude ratio is less than unity ($B2/B1 < 1$) because of geometrical spreading of the ultrasonic beam. Moreover, the higher the impact stress (when it certainly exceeds the threshold spall stress) the lower is the velocity and the amplitude ratio, while the backscattering intensity increases with impact stress (Fig. 8). In the case of amplitude spectrum of the reflected wave (B1), the high frequency component attenuates markedly with an increase in the impact stress (Fig. 9). These observations prove the ultrasonic characteristics - such as the wave velocity, amplitude ratio, backscattering intensity and amplitude spectrum - serve as a proper quantitative evaluation of the spall-damage.

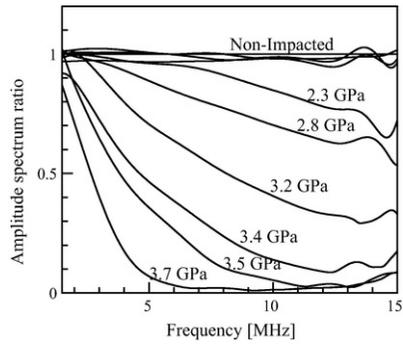
Fig. 9 Dependence of amplitude spectrum of backwall echo (B1) on impact stress. The indicated spectrum ratio was measured for the commercially pure iron after the first impact.

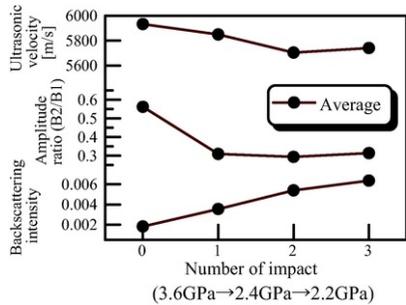
Fig. 10 Changes of ultrasonic velocity, amplitude ratio and backscattering intensity during the repeated impact test. The data correspond to C-scan images displayed in Fig. 6.

The measurement of the pertinent ultrasonic parameters was carried out for samples that were exposed to the repeated impact (*e.g.*, No. 17, the third impact stress is slightly lower than the threshold spall stress). As discussed in the preceding section, the acoustic images recorded for this particular sample do not provide sufficient information about the development of spall damage (see Fig. 6). However, the marked difference detected between velocities, amplitude ratios, backscattering intensity and amplitude spectrum recorded after the first, second and third impact (the values measured after the each impact changes in comparison with the previous one, see Figs. 10 and 11) make a ground to contend that spall damage increased during subsequent impact-events. This speaks in favor of the ultrasonic method we used to estimate the spall damage variation due to multiple impacts.

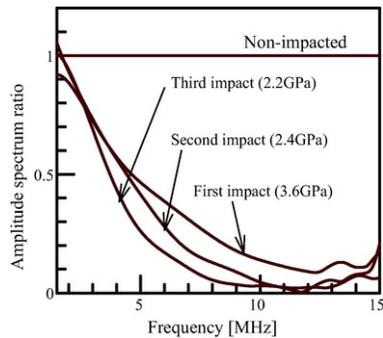
Fig. 11 Changes of amplitude spectrum during the repeated impact test. The data correspond to C-scan images displayed in Fig. 6.
