Evolution of spall-damage in iron caused by repeated plate impacts: Ultrasonic evaluation

Abstract

Keywords: Spall damage; Repeated plate impact test; Stress wave; Ultrasonic inspection; Non-destructive evaluation

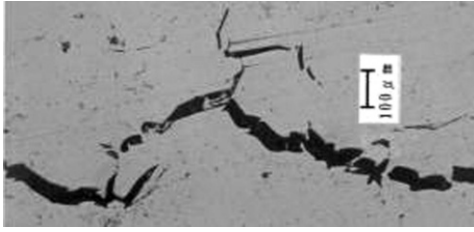
Fig. 7 The optical micrograph of the vertical cross-section of commercially pure iron specimen (sample No. N7) that indicates spall-damage to consists mainly of cracks. The image was taken after the first impact stress of 3.2 GPa.

The C-scan images (Figs. 4-6) reveal spall damage created in the commercially pure iron after the first (a), second (b) and third (c) impact. These images were taken in the determined region of the target plate with the same imaging conditions. The white spots caused by reflected signal indicate the defects. In the repeated plate impact tests, we applied different sequences of impact stresses to selected specimens (see the details in Table 2) in order to establish relationship between the stress level sequence of impacts and the resulting damage. Our experimental results are completed by optical microscopy observation of the spall damage (the example given in Fig. 7). Thus the change in these images shows the damage evolution.

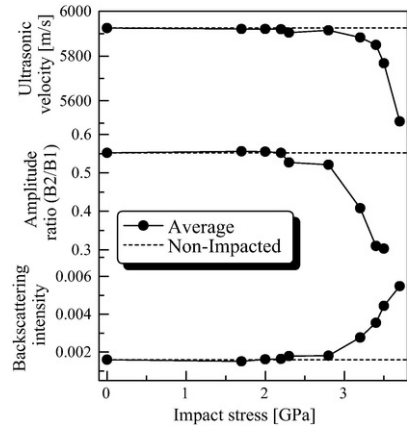
Fig. 8 Dependence of longitudinal wave (ultrasonic) velocity, amplitude ratio (equal B2/B1) and backscattering intensity on impact stress. The indicated ultrasonic variables were measured for the commercially pure iron after the first impact.

When the impact stress is lower than the threshold spall stress (approximately 2.3 GPa), the wave velocity, amplitude ratio, backscattering intensity and the amplitude spectrum are the same as for the non-impacted plates, as evident in Figs. 8 and 9. Indeed, even in the case of non-impacted plates, the amplitude ratio is less than unity ($B2/B1 < 1$) because of geometrical spreading of the ultrasonic beam. Moreover, the higher the impact stress (when it certainly exceeds the threshold spall stress) the lower is the velocity and the amplitude ratio, while the backscattering intensity increases with impact stress (Fig. 8). In the case of amplitude spectrum of the reflected wave (B1), the high frequency component attenuates markedly with an increase in the impact stress (Fig. 9). These observations prove the ultrasonic characteristics - such as the wave velocity, amplitude ratio, backscattering intensity and amplitude spectrum - serve as a proper quantitative evaluation of the spall-damage.

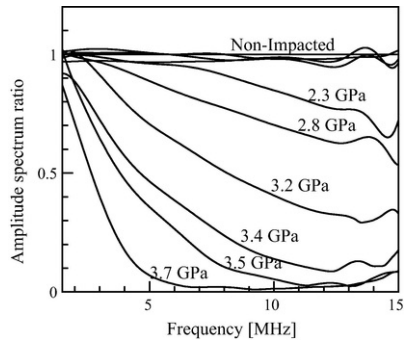
Fig. 9 Dependence of amplitude spectrum of backwall echo (B1) on impact stress. The indicated spectrum ratio was measured for the commercially pure iron after the first impact.

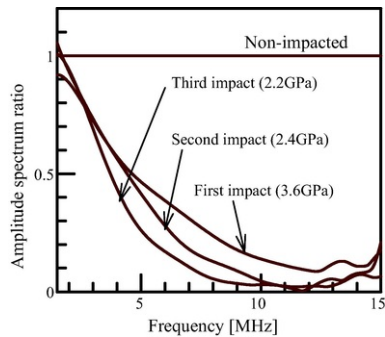
Fig. 11 Changes of amplitude spectrum during the repeated impact test. The data correspond to C-scan images displayed in Fig. 6.

The measurement of the pertinent ultrasonic parameters was carried out for samples that were exposed to the repeated impact (*e.g.*, No. 17, the third impact stress is slightly lower than the threshold spall stress). As discussed in the preceding section, the acoustic images recorded for this particular sample do not provide sufficient information about the development of spall damage (see Fig. 6). However, the marked difference detected between velocities, amplitude ratios, backscattering intensity and amplitude spectrum recorded after the first, second and third impact (the values measured after the each impact changes in comparison with the previous one, see Figs. 10 and 11) make a ground to contend that spall damage increased during subsequent impact-events. This speaks in favor of the ultrasonic method we used to estimate the spall damage variation due to multiple impacts.
